## A ROMAN CHIMNEY HOOD AT NEWPORT, ISLE OF WIGHT.

BY G. A. SHERWIN, F.S.A..

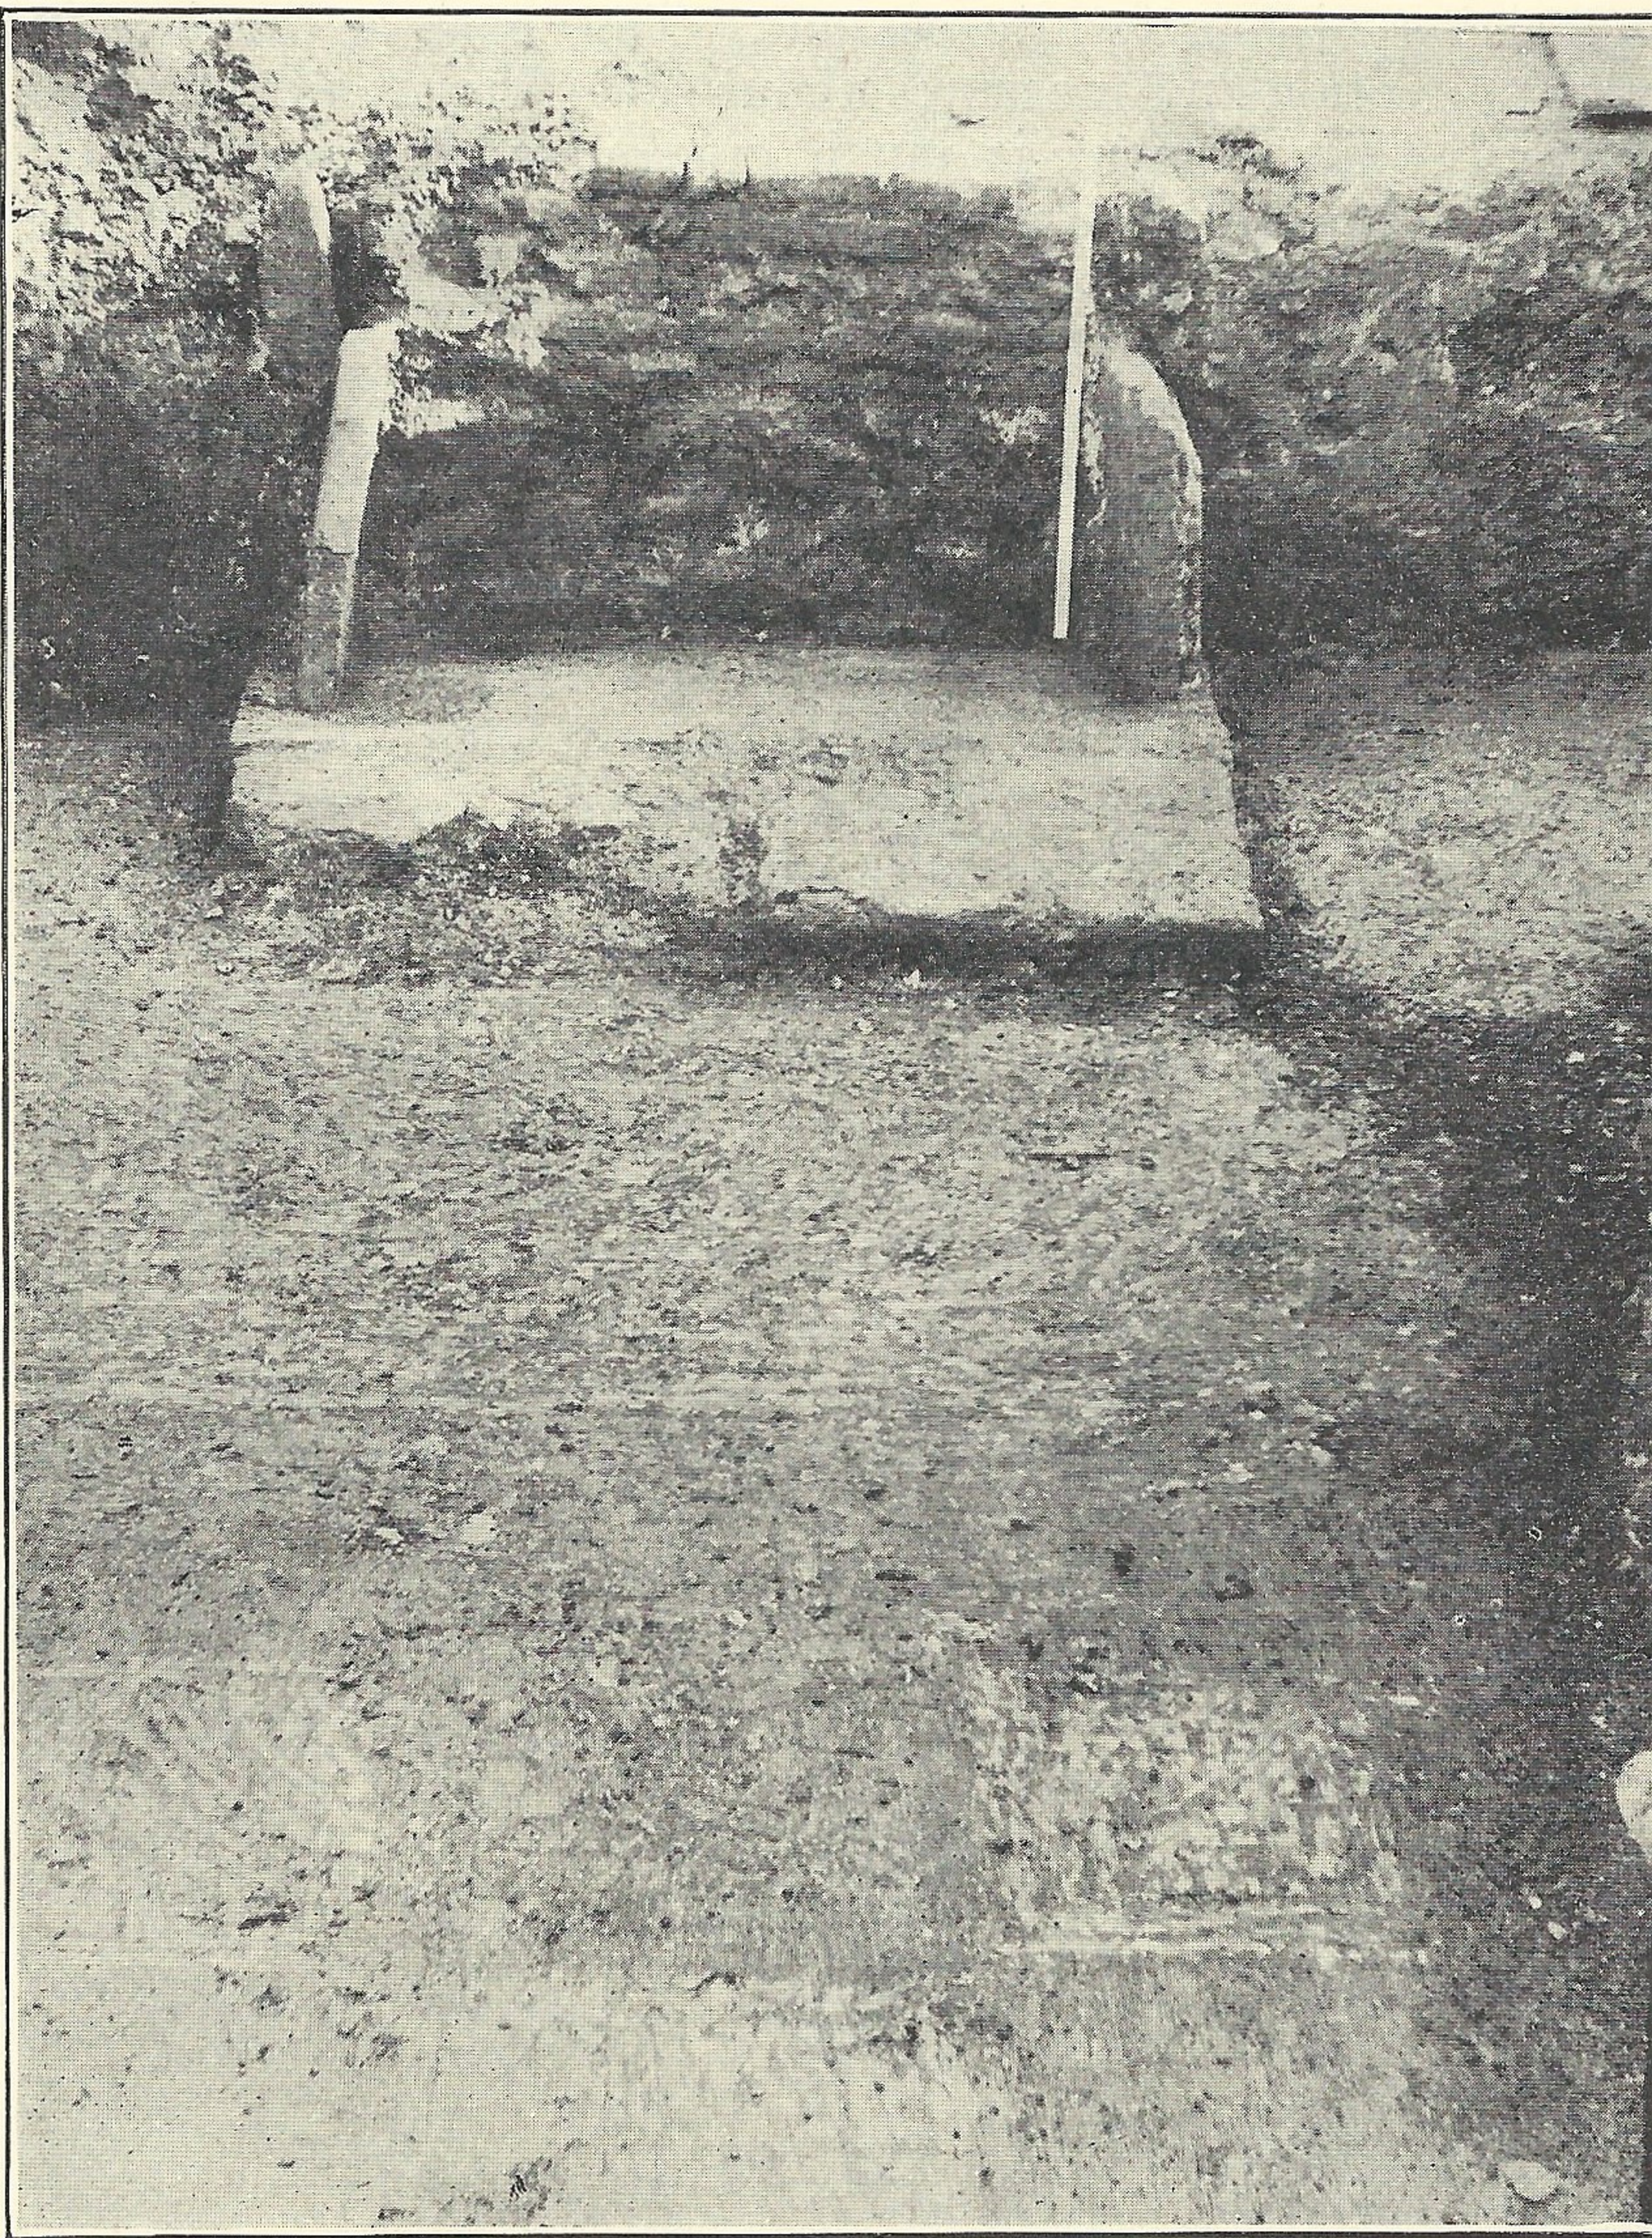
Fig. 2.—FIREPLACE IN ROOM V.

An account of the Villa was published in *The Antiquaries' Journal* for April, 1929, (Vol. IX., p. 141). Room V., which measures nineteen feet four inches by fifteen feet six inches and retains its tessellated floor in almost perfect condition, has a tile-built fireplace against its south wall. The hearth, of large tiles, measures two feet eight inches in width and two feet six inches from the outer edge to the wall. It rests upon a mortar bed about one inch thick, which is laid on the *tesserae* of the floor.

The rounded fireback is built into the wall in such a way that, while the centre is flush with the face of the wall, the sides project four inches and terminate three and a half inches from the edge of the hearth.

The back is made of pieces of tile one inch thick, laid in horizontal rows with joints of about half their thickness. Ten rows remain, reaching to the top of the existing wall, which is here one foot eight inches high. Supported by the angle between the wall and the edges of the fireback, a cheek-piece thirteen inches long by ten and a half inches high, consisting of a single tile one and a half inches thick, rests at each side upon the hearth, forming a shallow fire-chamber,

which shows considerable remains of a coating of plaster. The western cheek-piece had been displaced and broken, but has now been put back. The eastern one has not been disturbed and is covered outside with an inch-thick layer of coarse plaster rather roughly finished off with a thin coat of fine white cement. This plaster does not quite reach the edge of the hearth, which shows no evidence of a cement covering.

When the room was being excavated, a piece of moulded plaster was found lying near the hearth. Shortly after two more pieces, which fitted together and to the piece previously found, were recovered from the spoil heap. They have been carefully joined and form a block fourteen inches long, with a width ranging from six and a half inches near the top to four inches near the bottom, both ends being broken. The back shows the impression of the flank of an arch of small bricks to which it was attached. The front is ornamented with a curved fillet moulding, one inch wide on the face, with slightly splayed sides and about half an inch projection. Coming in at the broken left-hand top corner, it curves close along the left side and terminates with a square edge about one and a half inches from the bottom. It resembles very closely the drip moulding above a medieval window. The right-hand side of the block curves outward slightly toward the top and has a return face along its whole length, its greatest depth to the broken edge being three inches. The left-hand side is more broken but retains a piece of a return face about three inches long and two and a quarter inches deep. This piece, the adjoining edge of the block and the underside of the fillet, especially toward the top, are blackened by smoke. There seems no reason to doubt that it is the right-hand springer of a—presumably—semi-circular arch which formed the chimney hood of the fire-place. Both side faces splay slightly outward. The construction consists of about an inch of coarse yellow plaster into which the bricks were keyed, covered by an inch of pink cement worked to a smooth surface and finished off rather roughly with one-eighth to one-quarter of an inch of hard white cement. The fillet was worked in the pink cement before receiving the finishing coat of white.

impression of bricks and having its base covered by a quarter-inch layer of hard white cement. This base is concave in every direction and measures about seven inches across. The coat of white cement is much cracked and blackened by fire. It appears to be part of a semi-dome which roofed the interior of the fireplace. Judging by its shape, it must have filled an angle, and it may be noted that the marks of the bricks on one side are at right angles to those on the other.

Another find near the fireplace was a tile one and a half inches thick and originally about twelve inches square, which seems to have been worked into a sort of bracket. From one corner, a piece, roughly square and containing about a quarter of the entire tile, appears to have been removed with some care. From the corner diagonally opposite, the edge slopes inward for seven and a quarter inches and then runs more or less parallel with the above square to form an arm about three inches wide projecting from the main body of the tile. This may be due to natural fracture but the square removed has every appearance of being intentional and the tile perhaps formed part of the construction of the fireplace; *e.g.*, a bracket to support the arch on which the front was moulded. The flimsy nature of the cheek-pieces, a single tile set on edge, implies that the real substance of the chimney hood was cement, for which the tiles simply formed a foundation.
